MARINE POLLUTION SURVEILLANCE REPORT

Analysis Provided by: The National Oceanic and Atmospheric Administration/National Environmental Satellite, Data and Information Service (NOAA/NESDIS)

REPORT DATE: AUGUST 11, 2012
REPORT TIME: 0100Z (08/10/2012 2000 CDT)
ANALYST: TURK

DATA SOURCE: LANDSAT-7
MODE: MULTI-SPECTRAL
RESOLUTION: 30 METER
IMAGE DATE/TIME: 8/10/2012 1621Z (1121 CDT)

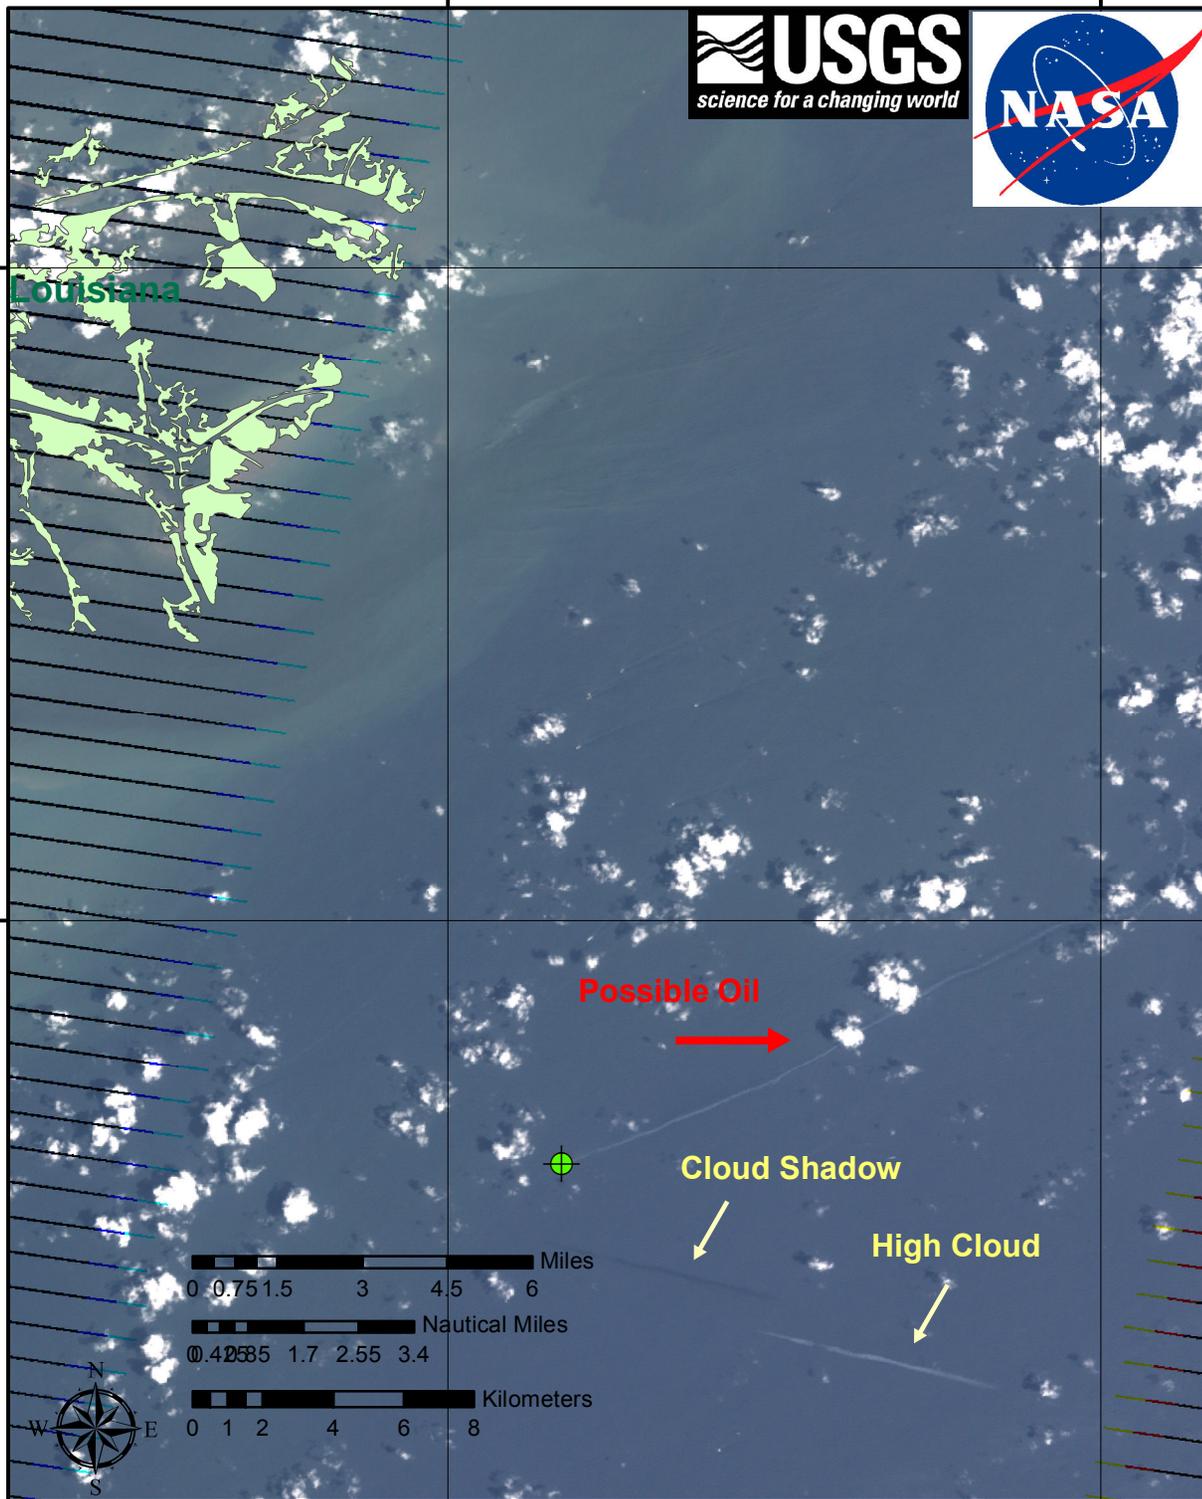
- Possible Oil
- False-Positives (not oil)
- Destroyed Taylor Platform :
[28°56'9" N / 88°58'12" W]

A narrow 0.2 mile wide oil slick extended at least 11 miles to the northeast of the destroyed Taylor platform. Scattered clouds were present and the winds were from the west-southwest at 10 knots at the time the image was taken.
