## MARINE POLLUTION SURVEILLANCE REPORT

Analysis Provided by: The National Oceanic and Atmospheric Administration/National Environmental Satellite, Data and Information Service (NOAA/NESDIS)

REPORT DATE: JUNE 01, 2012 REPORT TIME: 2245Z (1745 CDT)

Destroyed Taylor Platform: [28°56'9" N / 88°58'12" W]

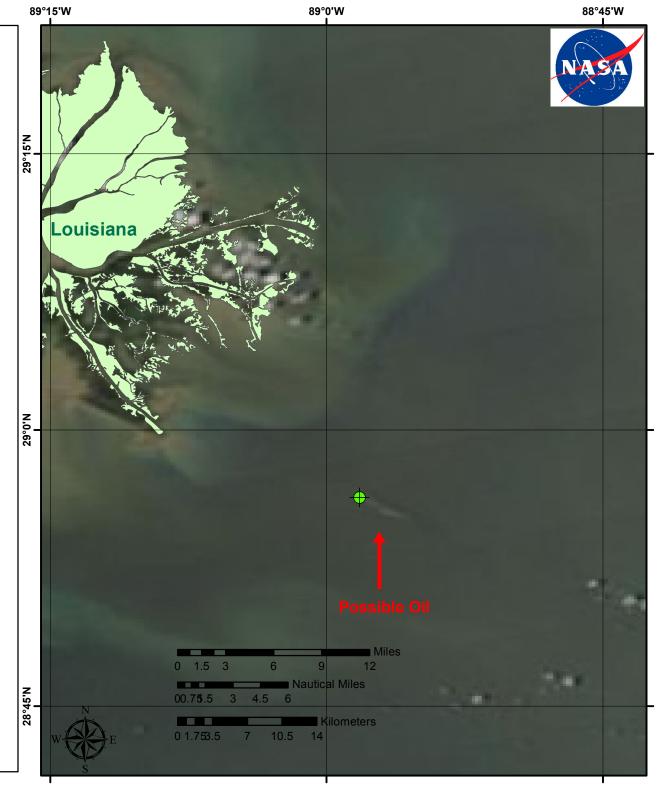
A suspected oil slick extended 3.1 miles to the east-southeast of the destroyed Taylor platform. The slick was approximately 0.5 mile wide. Winds were from the northwest at 10-15 knots and sky conditions were mostly clear at the time of the image.
