## MARINE POLLUTION SURVEILLANCE REPORT

Analysis Provided by: The National Oceanic and Atmospheric Administration/National Environmental Satellite, Data and Information Service (NOAA/NESDIS)

REPORT DATE: JUNE 19, 2011 REPORT TIME: 2015Z (1515 CDT)

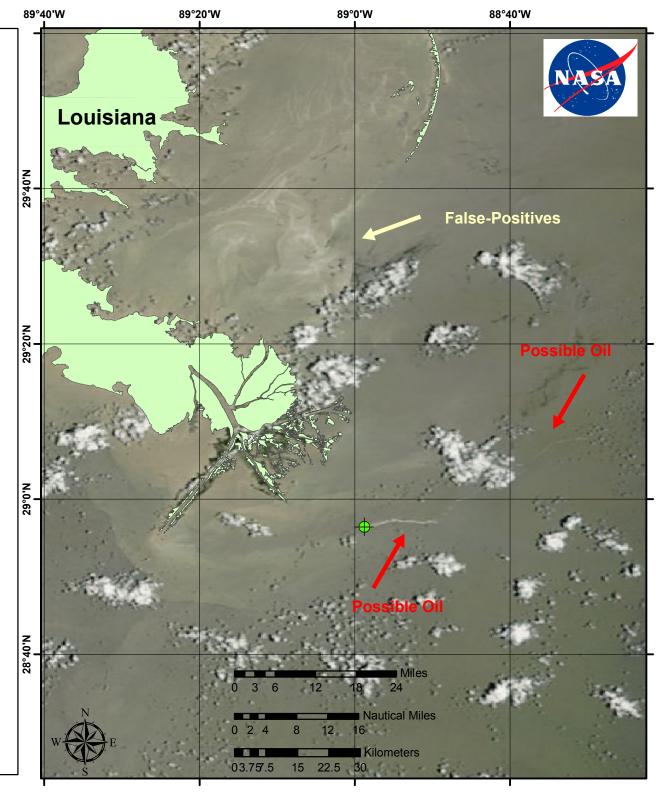
Destroyed Taylor Platform: [ 28°56'9" N / 88°58'12" W ]

REMARKS: Oil slicks seen stretching east-northeast from Destroyed Taylor Platform. Oil slick is thirty-two miles long and averaging about 1 mile wide. There are two separate oil slicks due to cloud cover blocking the view and the connection of the two slicks. Latest wind data indicates oil slicks should continue to move toward the east-northeast.
