# MARINE POLLUTION SURVEILLANCE REPORT

REPORT DATE: JUNE 30, 2012  
REPORT TIME: 1945Z (1445 CDT)  
ANALYST: MYRGA

DATA SOURCE: MODIS TERRA  
MODE: MULTI-SPECTRAL  
RESOLUTION: 250 METER  
IMAGE DATE/TIME: 6/30/2012 1645Z (1150 CDT)

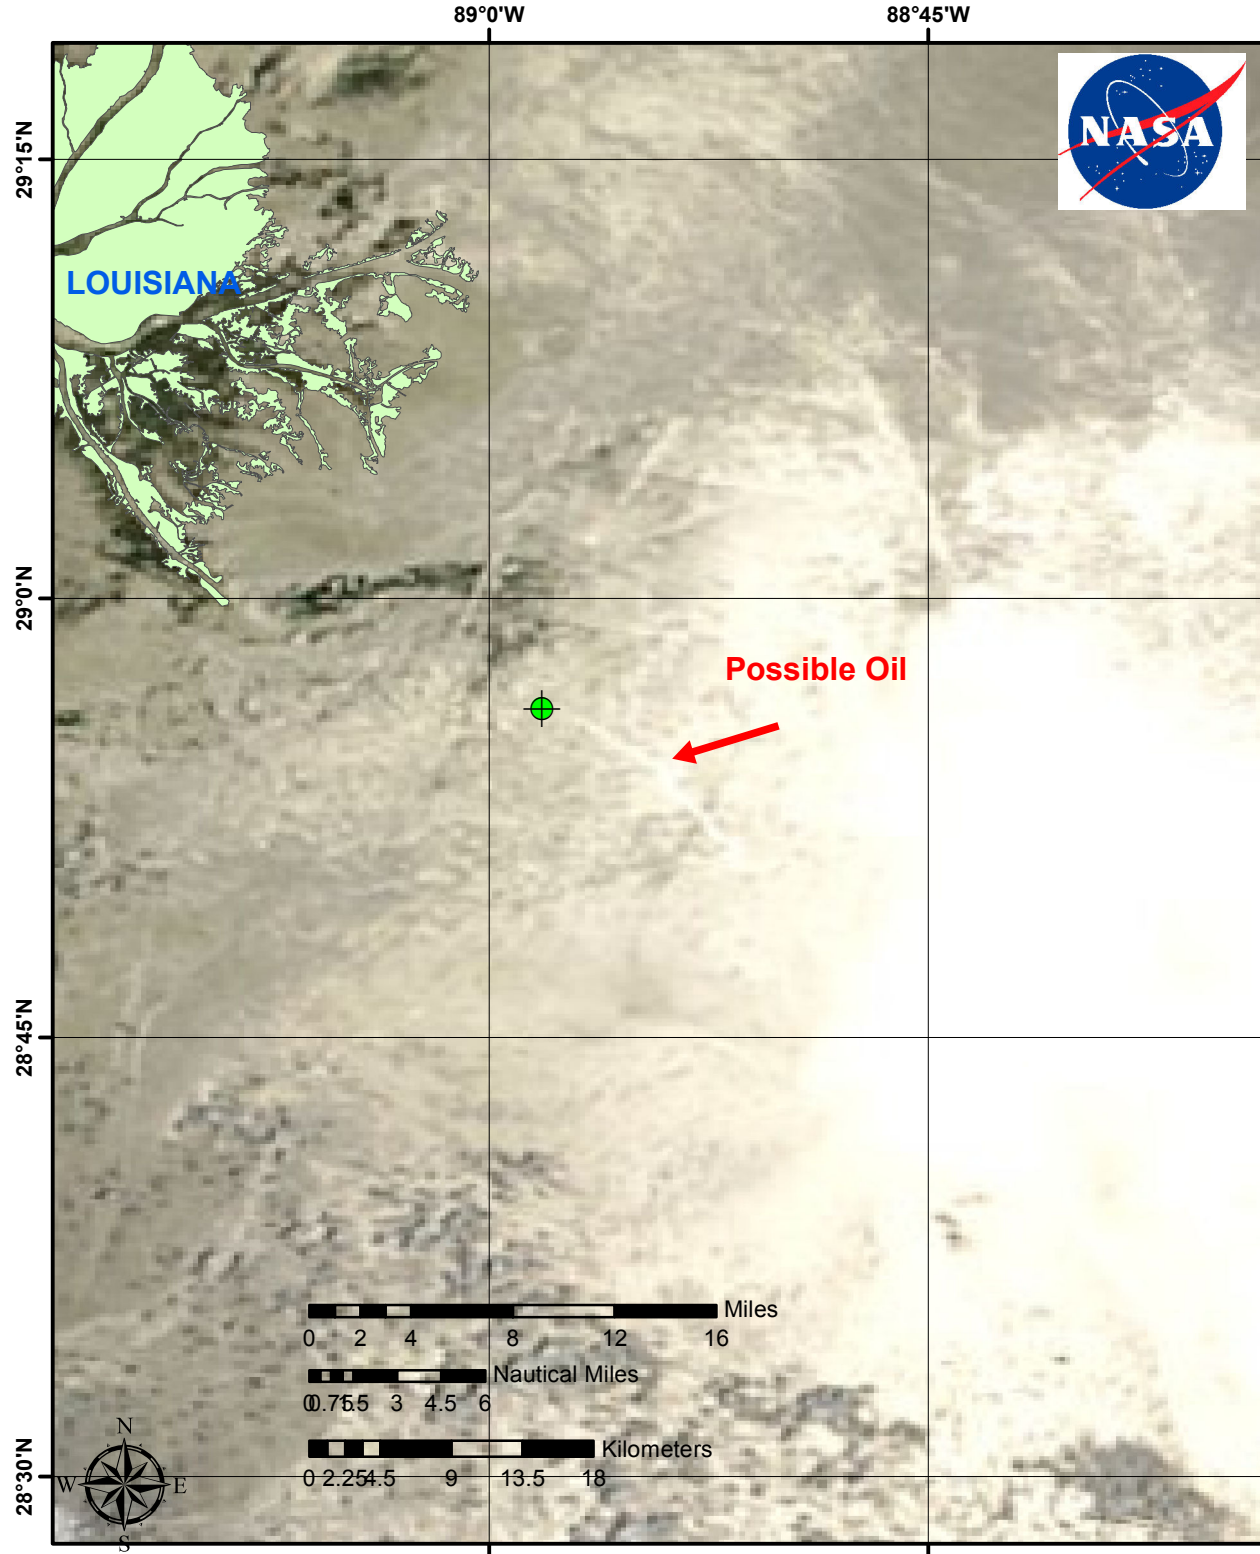
A possible oil sheen extended approximately 9 miles SE  
of the destroyed Taylor platform. Winds were light and  
from the west. Sky conditions were mostly clear at time  
of image; however, a large area of sunglint is just east of  
this area.
