MARINE POLLUTION SURVEILLANCE REPORT

Analysis Provided by: The National Oceanic and Atmospheric Administration/National Environmental Satellite, Data and Information Service (NOAA/NESDIS)

REPORT DATE: AUGUST 10, 2012 REPORT TIME: 2015Z (1515 CDT)

Destroyed Taylor Platform: [28°56'9" N / 88°58'12" W]

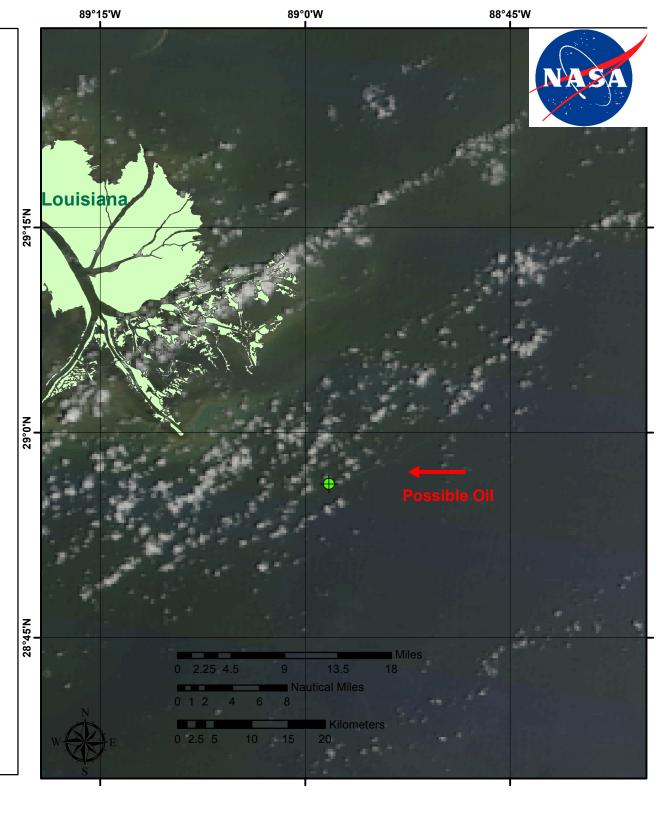
A possible 0.5 mile wide oil slick extended 8.8 miles to the northeast of the destroyed Taylor platform. Scattered clouds were present and the winds were from the westsouthwest at 10 knots at the time the image was taken.
