EXPERIMENTAL MARINE POLLUTION SURVEILLANCE REPORT

REPORT DATE: OCTOBER 15, 2010

DATA SOURCE: ENVISAT ASAR © ESA 2010

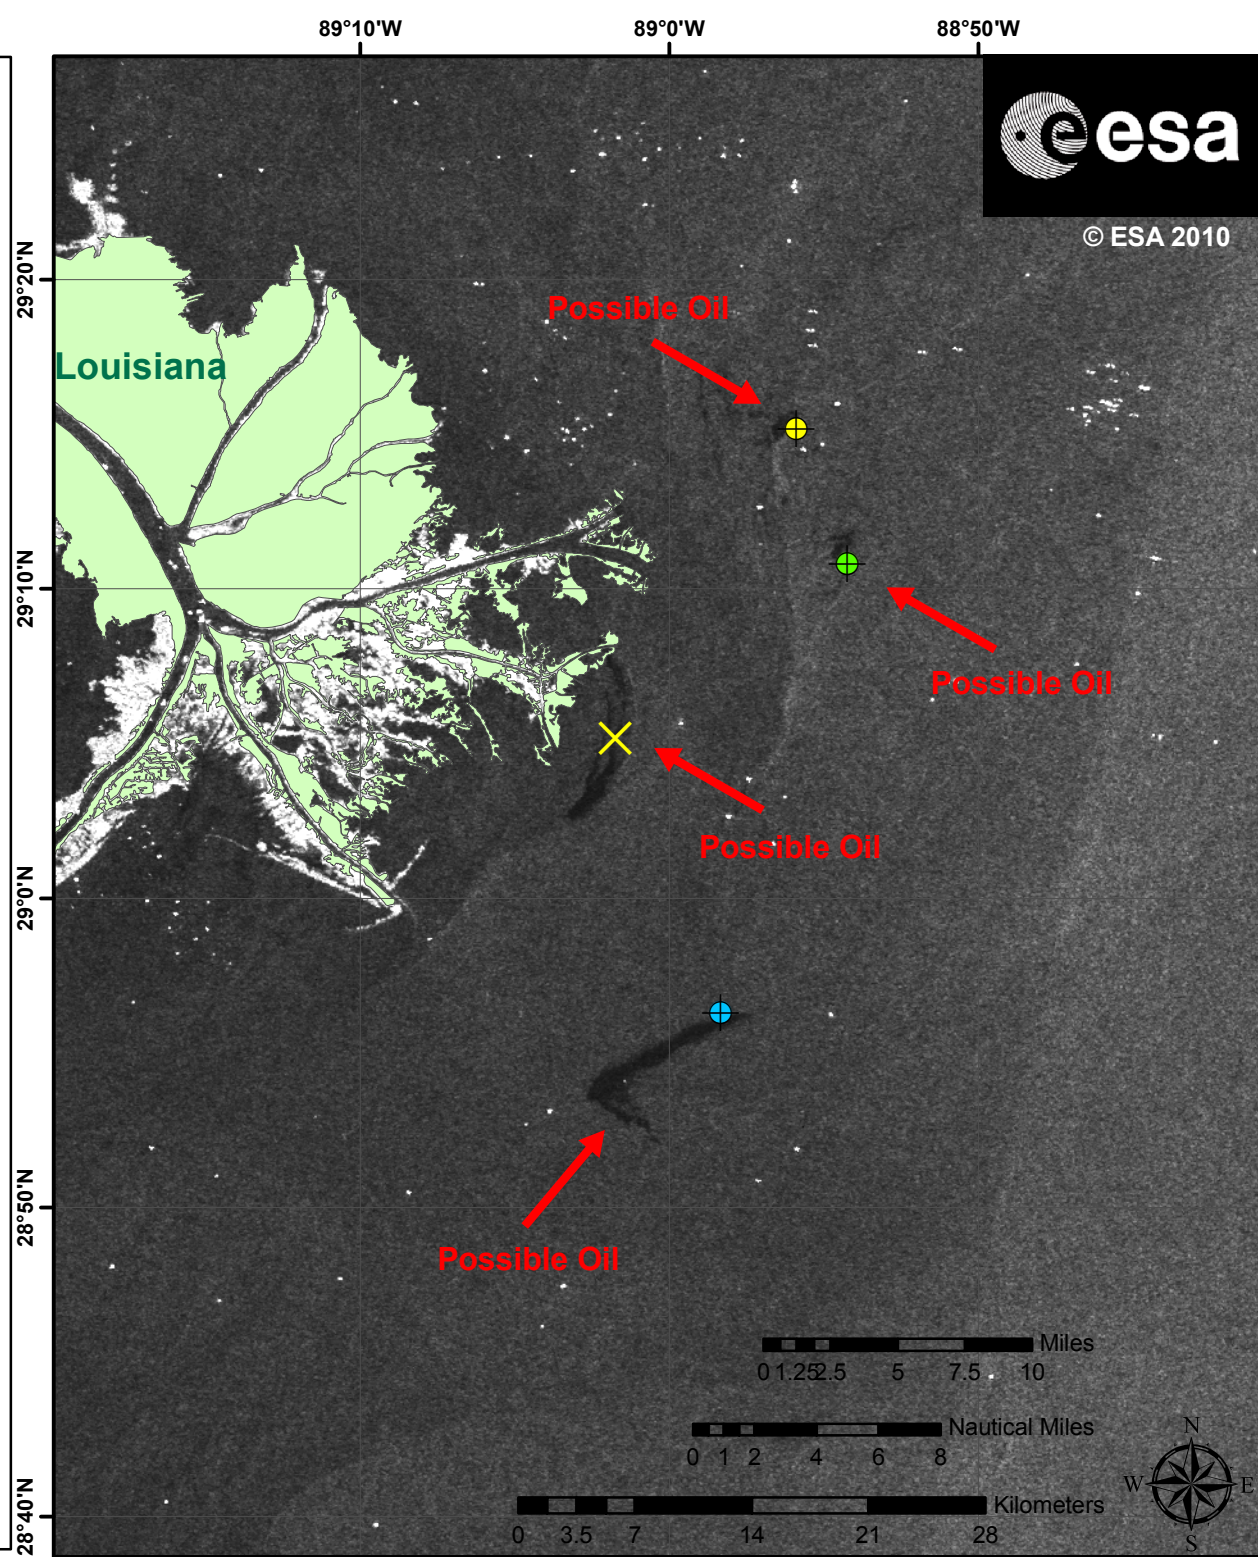
Destroyed Taylor Platform :
[28°56'9" N / 88°58'12" W]
-

Suspected Point Source :
[29°15'11" N / 88°55'54" W]
-

Suspected Point Source :
[29°10'49" N / 88°54'15" W]
-

Center Point of Oil Slick:
[29°05'08" N / 89°01'38" W]

High confidence in oil slick from destroyed Taylor platform site southeast of Bird's Foot.

Medium-high confidence in 2 point source possible slicks 6-7 miles east of the Bird's Foot.

Medium confidence in suspected oil 1.25 miles east of Blind Bay in Bird's Foot.
