MARINE POLLUTION SURVEILLANCE REPORT

Analysis Provided by: The National Oceanic and Atmospheric Administration/National Environmental Satellite, Data and Information Service (NOAA/NESDIS)

REPORT DATE: MAY 25, 2015
 REPORT TIME: 1900Z (1200 PDT)
 ANALYST: JANKOT

DATA SOURCE: WORLDVIEW-2
 MODE: Multispectral
 RESOLUTION: 1.8 meter
 IMAGE DATE/TIME: 5/24/2015 1840Z (1140 PDT)

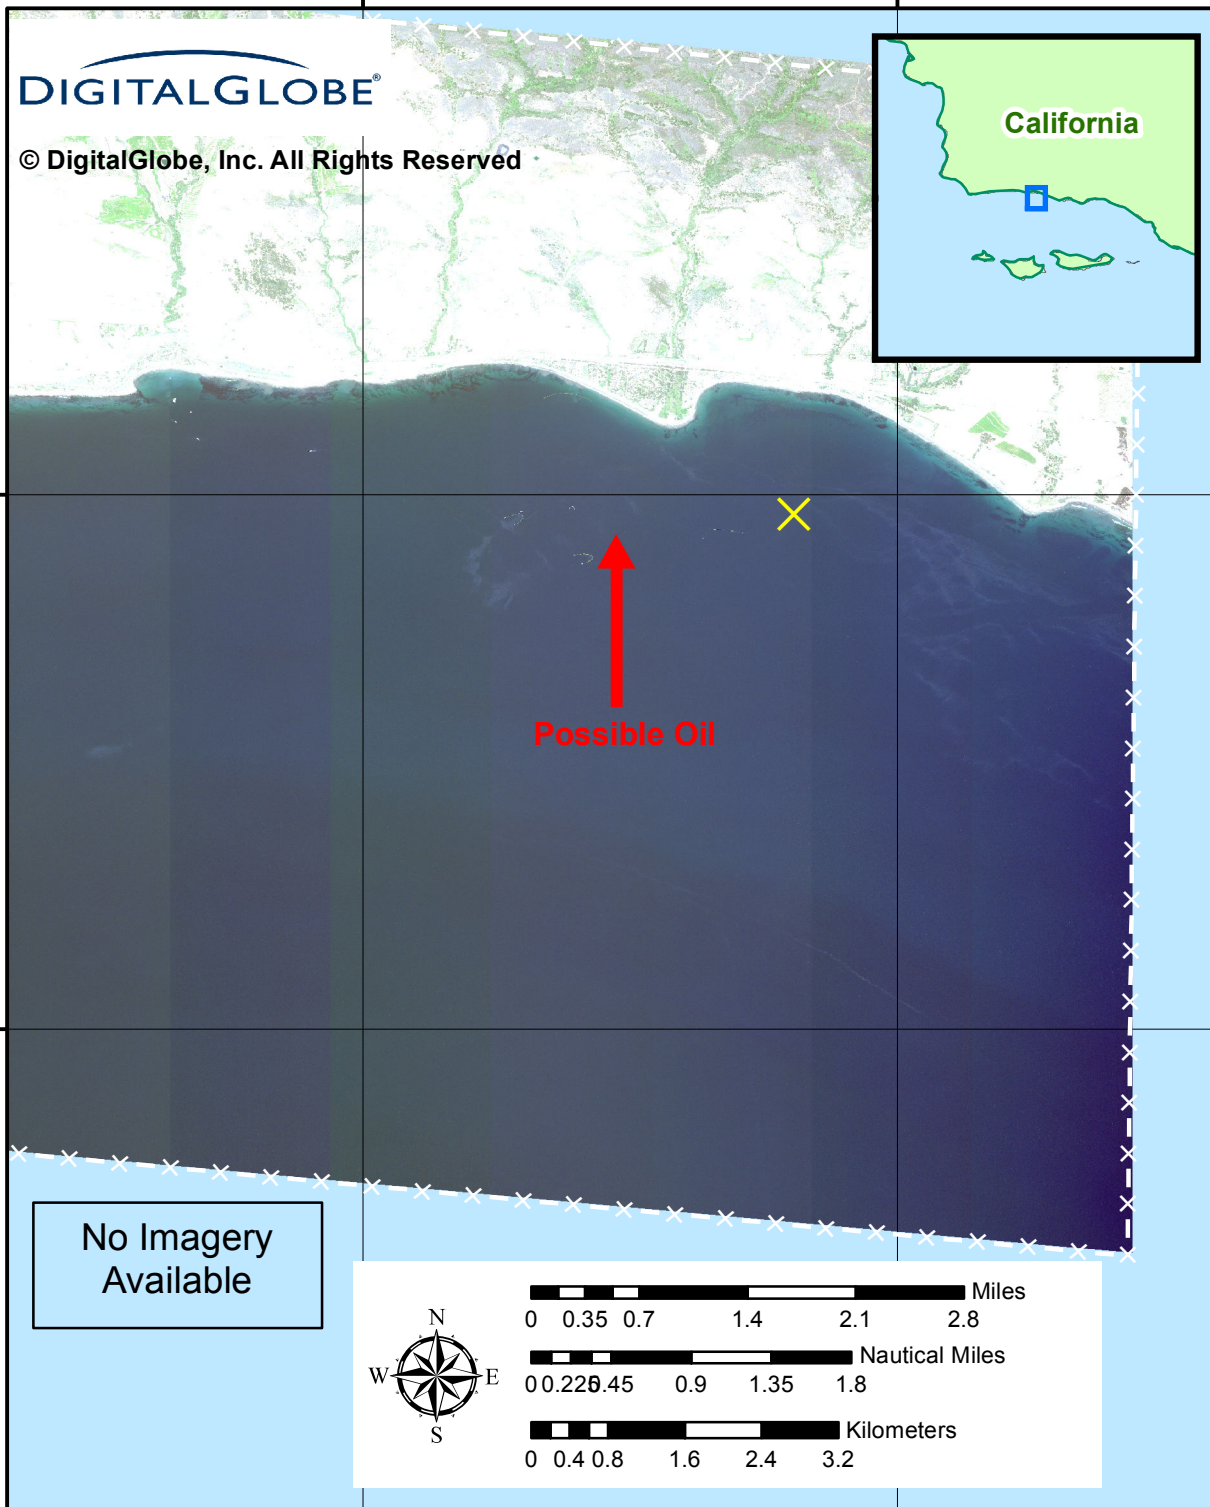
- Possible Oil
- False-Positive (not oil)
- Center Point of Oil Slick:
[34°26'36" N / 120°0'53" W]
- 3.9 km² Area of Possible Oil

CONFIDENCE: Medium-High

Possible oil related to the Refugio Incident is analyzed in the Worldview-2 image taken yesterday 5/24/15. Confidence is medium-high given that oil can't be distinguished from natural seeps vs the pipeline rupture. The anomaly tested negative for vegetation false positive and appeared a lighter white color from its surroundings, a common oil signature seen in multispectral imagery. Please note that the dashed white line denotes the boundary of available imagery. We are unable to analyze possible oil outside of this boundary.
