MARINE POLLUTION SURVEILLANCE REPORT

Analysis Provided by: The National Oceanic and Atmospheric Administration/National Environmental Satellite, Data and Information Service (NOAA/NESDIS)

REPORT DATE: AUGUST 24, 2012
REPORT TIME: 2115Z (1615 CDT)
ANALYST: RAMIREZ

Destroyed Taylor Platform :
[28°56'9" N / 88°58'12" W]

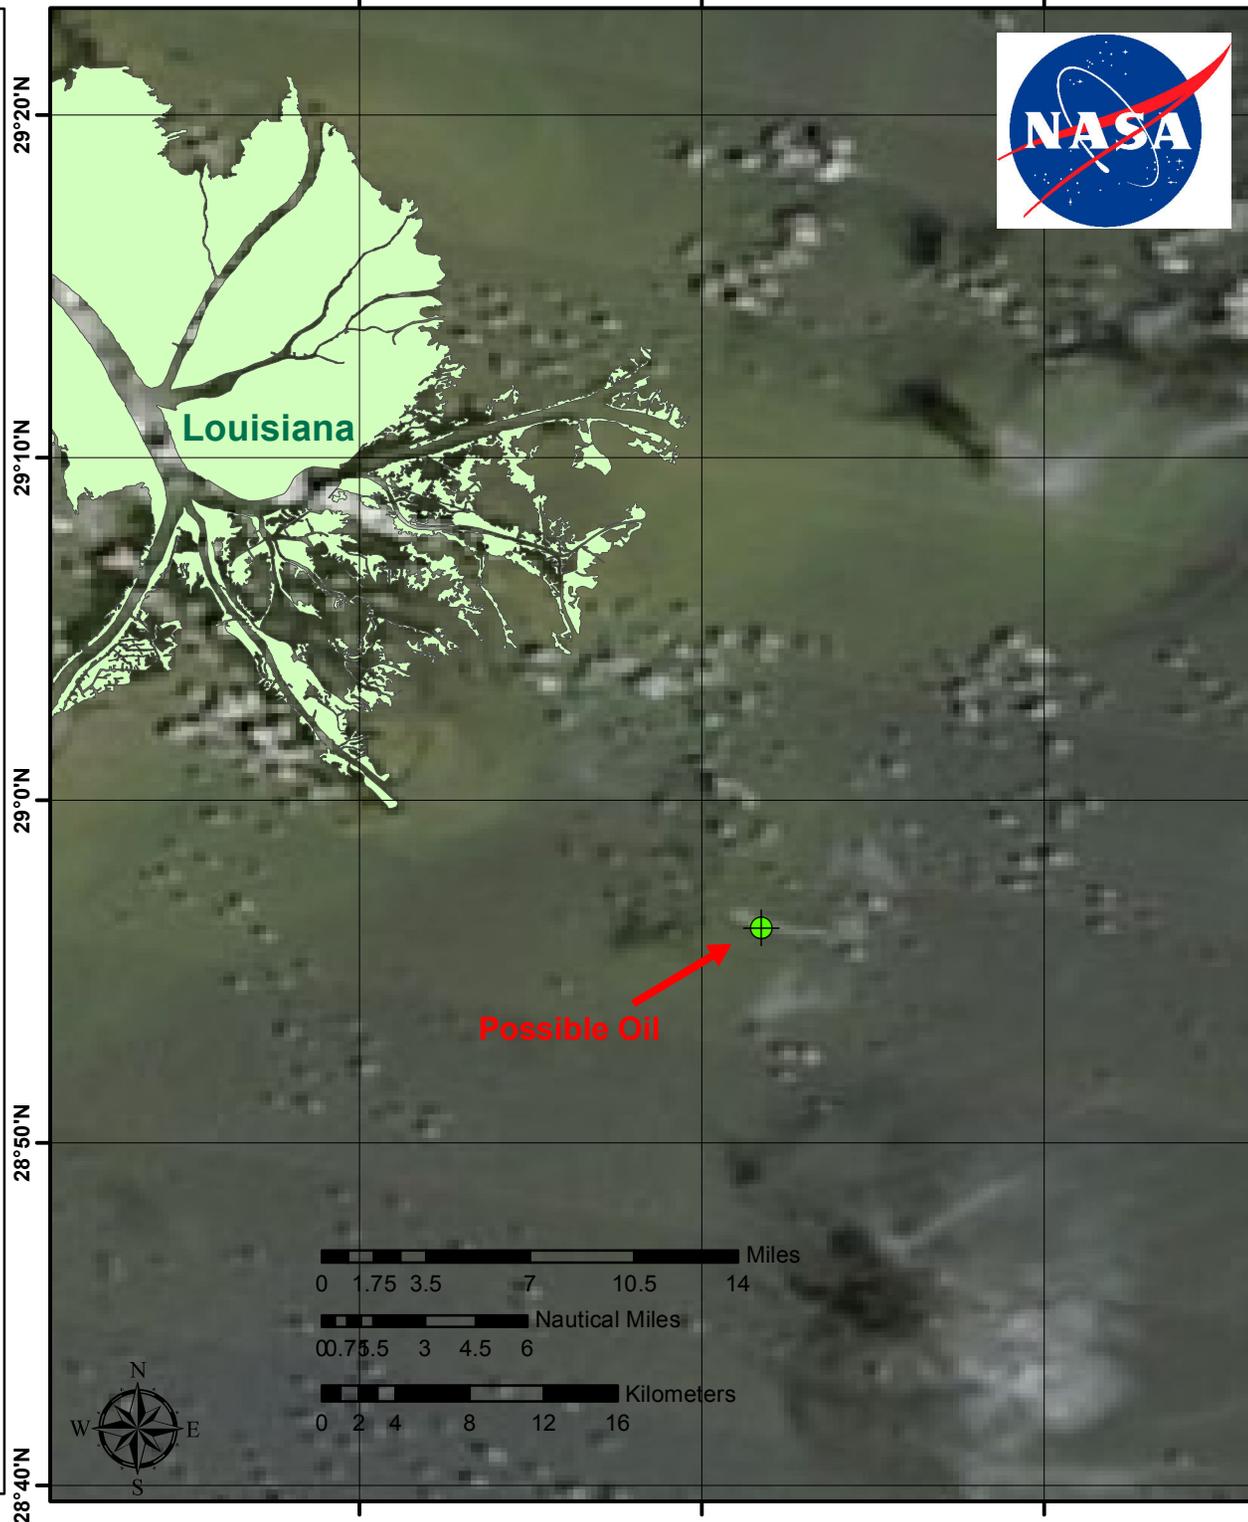
REMARKS: A suspected oil slick appears to be extending west for 2km and east for 3km from a known leak site. Confidence is reduced due to the presence of clouds in the vicinity giving the feature less of a contrast with its surroundings. However, the teardrop-ish shape of the feature, which is consistent with pooling in low wind scenarios, gives it distinction from the nearby clouds. The anomaly is located in between two gyres and therefore the winds are light to variable.
