EXPERIMENTAL MARINE POLLUTION SURVEILLANCE REPORT

REPORT DATE: APRIL 19, 2011
REPORT TIME: 0030Z (4/18/2011 1930 CDT)
ANALYST: MYRGA

DATA SOURCE: LANDSAT-7
MODE: ETM+ MULTI-SPECTRAL
RESOLUTION: 30 METER
IMAGE DATE/TIME: 4/18/2011 1619Z (4/18/11 1119 CDT)

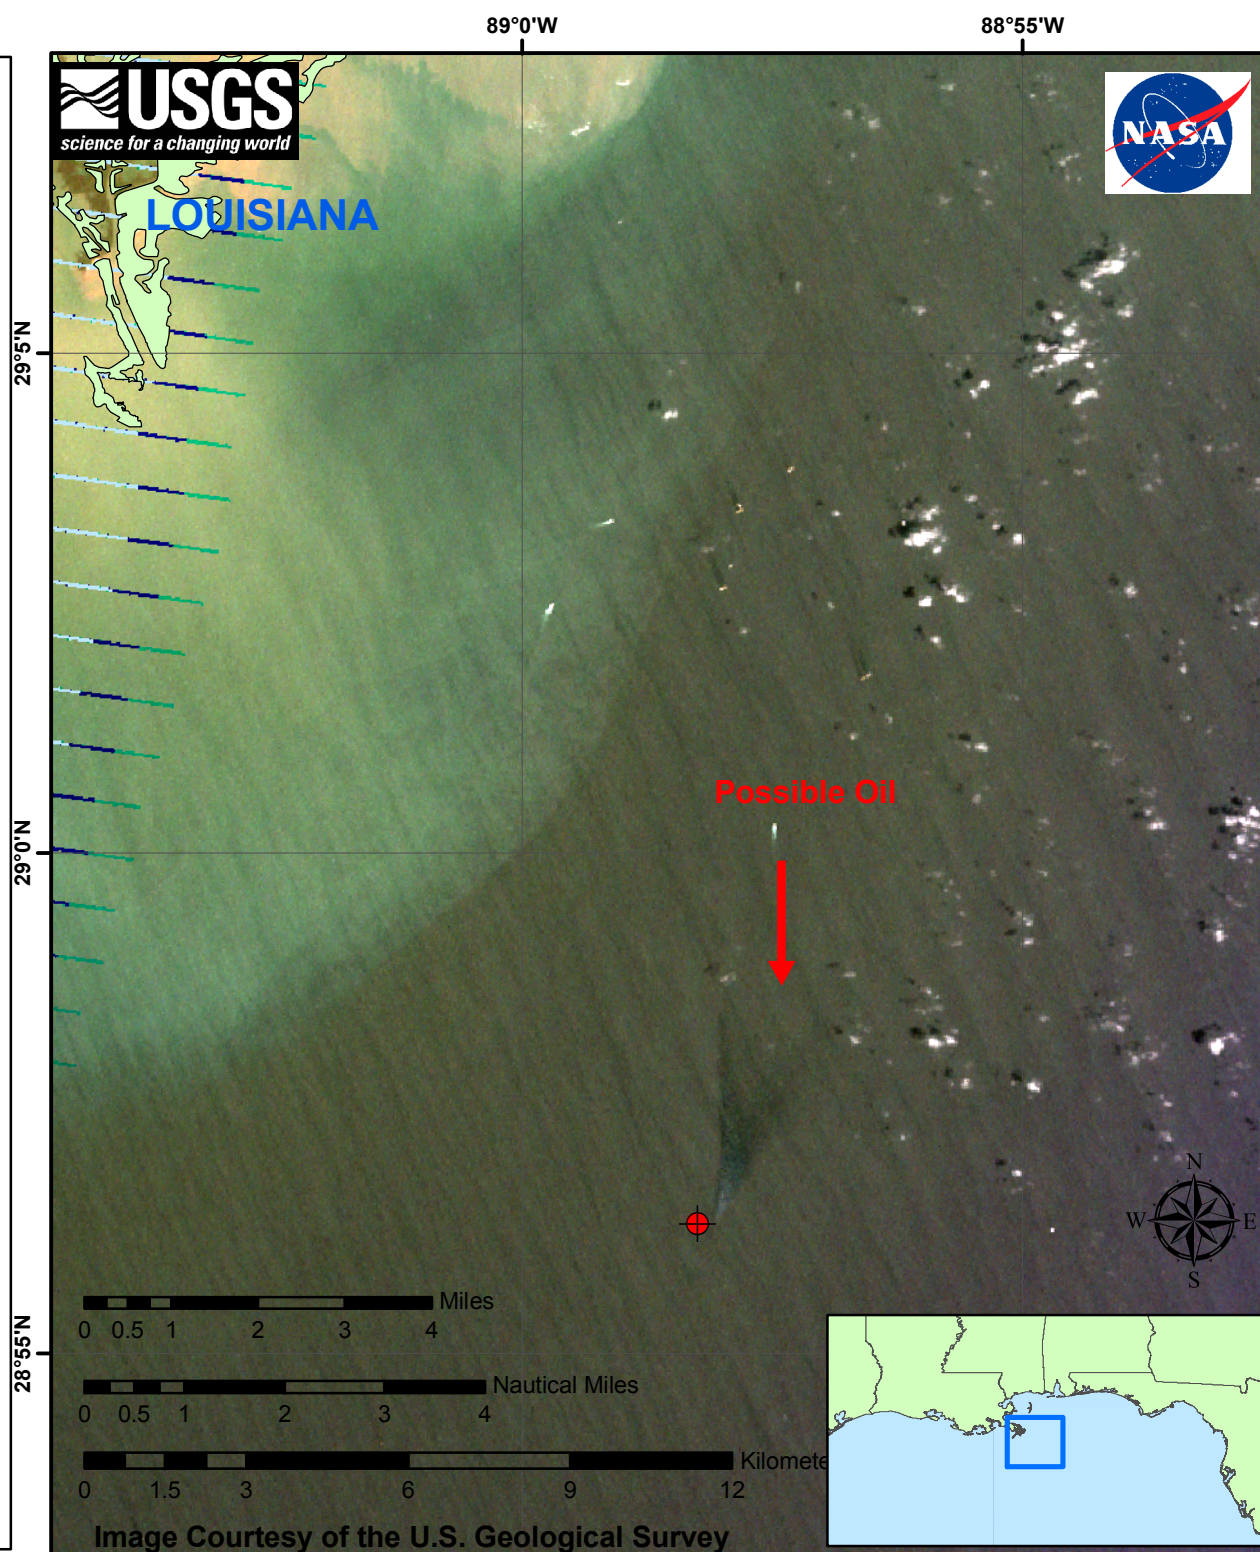
Destroyed Taylor Platform:
[28°56'9" N / 88°58'12" W]

An anomaly (assumed oil slick) is located near the
destroyed Taylor Platform in the Gulf of Mexico. The
slick is north and east of the platform and extends about
2 miles from the source.
