MARINE POLLUTION SURVEILLANCE REPORT

Analysis Provided by: The National Oceanic and Atmospheric Administration/National Environmental Satellite, Data and Information Service (NOAA/NESDIS)

REPORT DATE: APRIL 11, 2012 REPORT TIME: 2045Z (1545 CDT) ANALYST: TURK/RAMIREZ

DATA SOURCE: MODIS TERRA

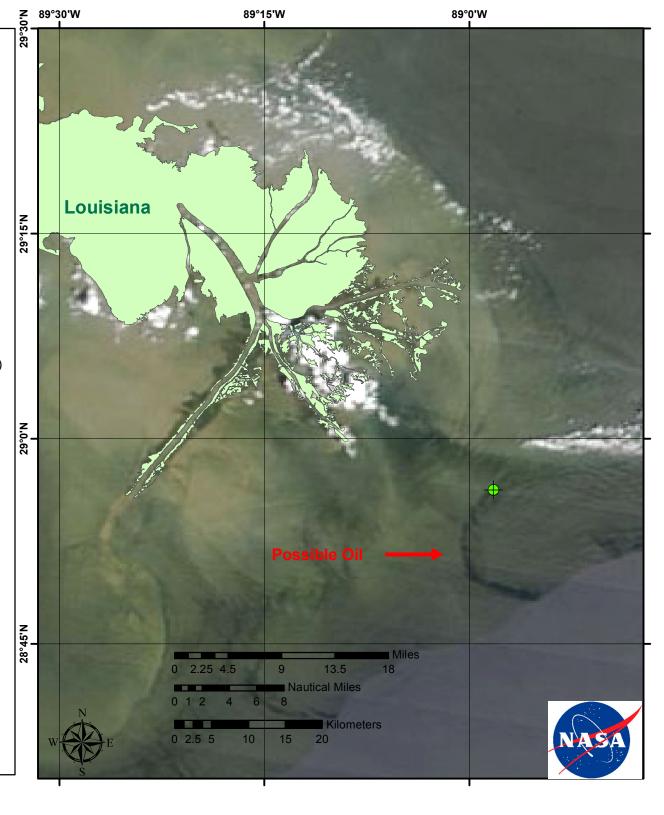
A possible oil slick was detected approximately 20.5 miles to the southeast of the Birds Foot. The slick extended 5.8 miles to the southwest of the point source before curving another 6.2 miles to the east southeast of there. The area was under clear skies at the time with light winds from the north at 5 knots.
