MARINE POLLUTION SURVEILLANCE REPORT

REPORT DATE: MAY 13, 2012
REPORT TIME: 1930Z (1430 CDT)
ANALYST: BELGE

DATA SOURCE: TERRA MODIS
MODE: Multispectral
RESOLUTION: 250 meter
IMAGE DATE/TIME: 5/13/2012 1645Z (1145 CDT)

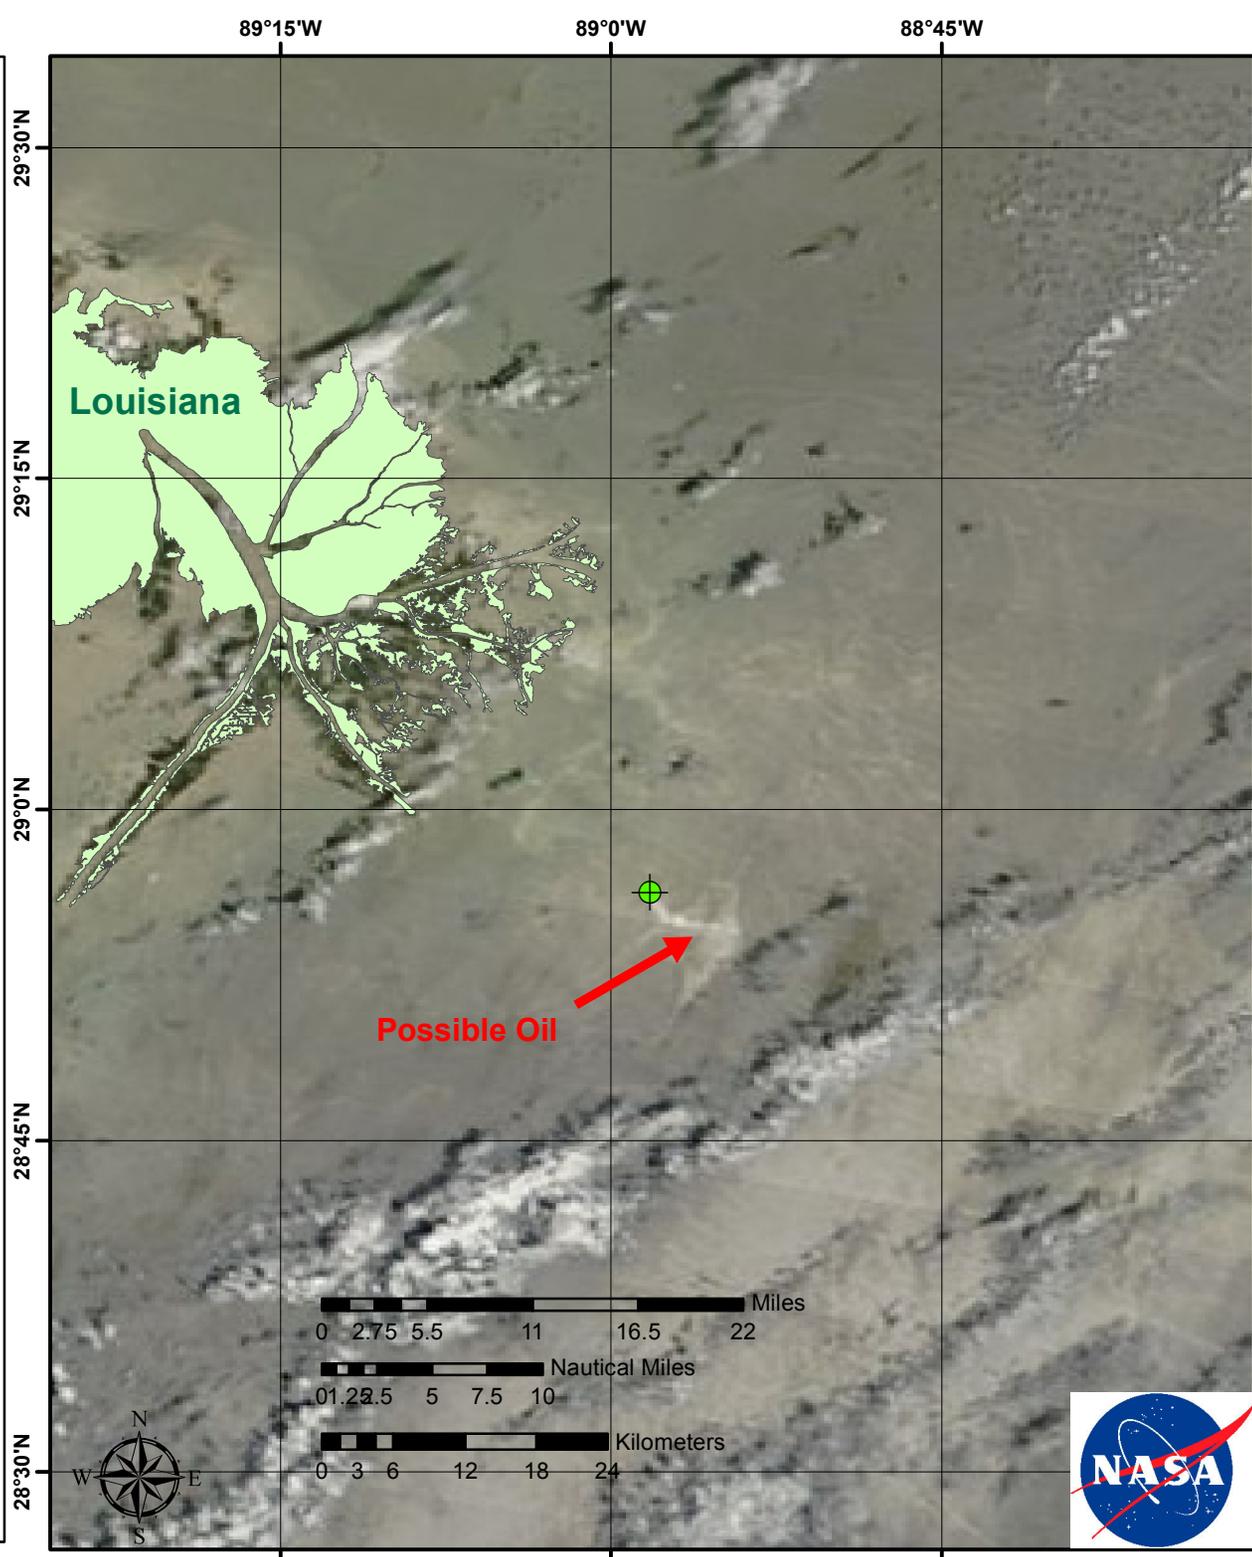
Destroyed Taylor Platform :
[28°56'9" N / 88°58'12" W]

An area of possible oil can be seen coming from the destroyed Taylor Energy Platform in this afternoon's MODIS Terra imagery. The slick was seen extending about 8 km to the south/southeast of the Platform.
